FARM ENVIRONMENT PLAN

LUDF

SHANDS RD, Burnham

15 August 2019

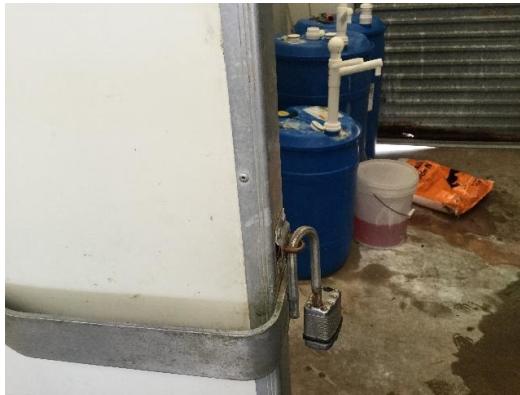
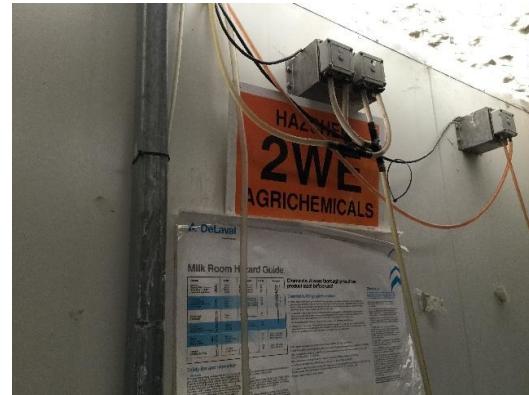
F2

Theer is a chemical shed on farm that stores dairy shed chemicals and chemicals for spot spraying. The chemical shed is lockable and has appropriate signage.

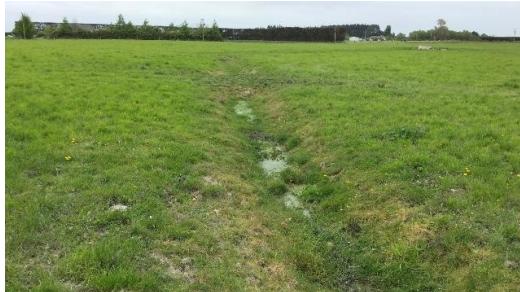
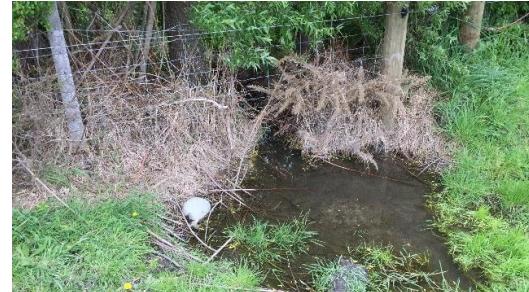
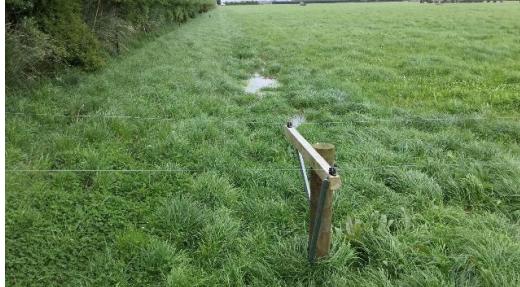
L2

There are two overland flow paths that run through the paddock and run directly to the drain allowing nutrients and sediment to flow directly into the waterway.

All sediment and phosphorus risk areas need to be managed to ensure they dont have an affect on the water quality.

Stock exclusion

Stock exclude this area when cows are in this paddock, this could be temporary or permanent fencing.

TARGET DATE: 30 Jan 2019

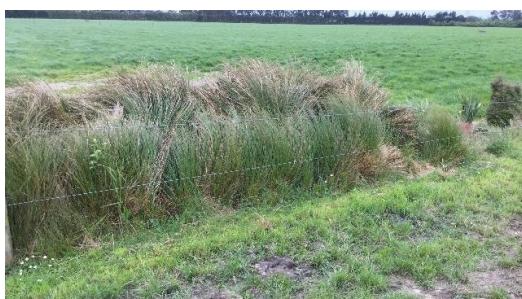
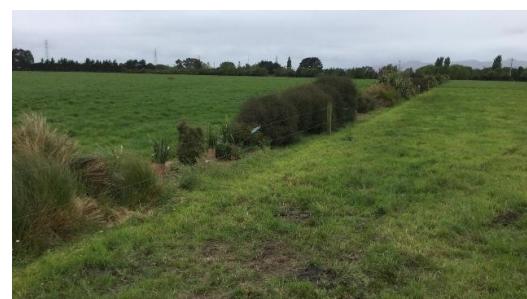
L3

The corners of north block have been fenced and planted in natives, this decision was made to add biodiversity corridors and shelter to the farm. The fenceline has also been planted with native plants as a shelterbelt and biodiversity corridor. Carex are planted to stop erosion of the bank. The plantings are planted and maintained by Steve Braileford.

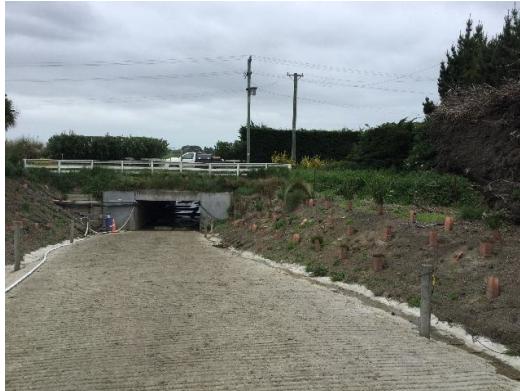
L5

There is a underpass that joins the north block and the south block. Any effluent collected from the underpass is directed into the effluent system which is in close proximity.

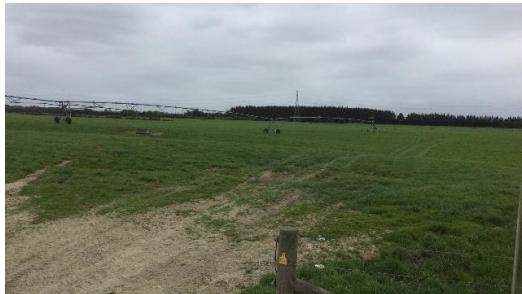
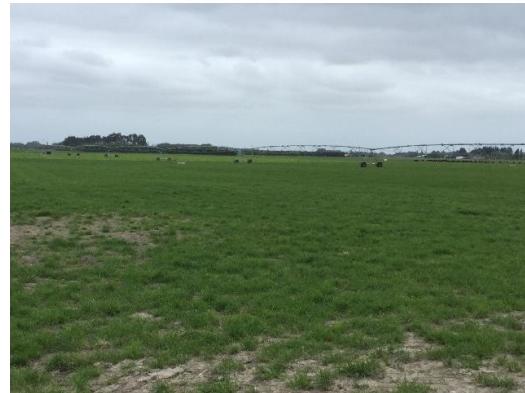
I1

The farm irrigates 175 ha. All water takes via bores are consented and monitored via water meters and telemetry. This measures irrigation and stock water.

The irrigation methods on farm are 115ha of pivots, 36ha of long line sprinklers, 12ha of hard hose guns and 10ha of k line. The system was designed by Waterforce as per design plans. Irrigation events are recorded. The gun has set locations for its runs as does the sprinklers and k lines by using GPS on the bike.

Irrigation scheduling relies on the Aquaflex soil moisture tape which is applied at four sites over the four main soil types. There is also a VRI system in place on the north pivot, which is used to vary the amount of water across the different soil types and exclude non productive areas. The effluent will be getting Scada shortly so they can use solarnoides on the effluent line.

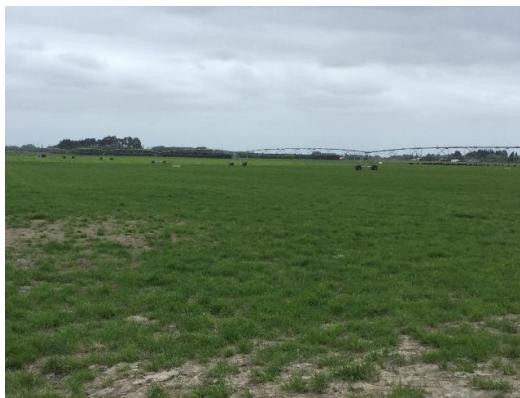
**EFFLUENT MANAGEMENT**
E1

Effluent is applied to 34ha of the farm, underslung from the pivot.
Effluent applications are recorded in the dairy diary daily.

A regular maintenance programme is in place to ensure efficient and compliant use of effluent. On a daily basis filters at the sump are cleaned and pots unblocked. Details of repairs and maintenance are recorded in the dairy diary.

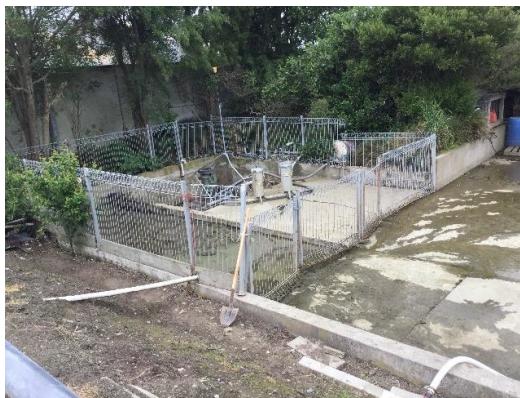
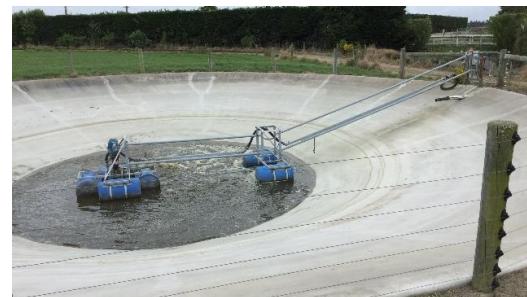
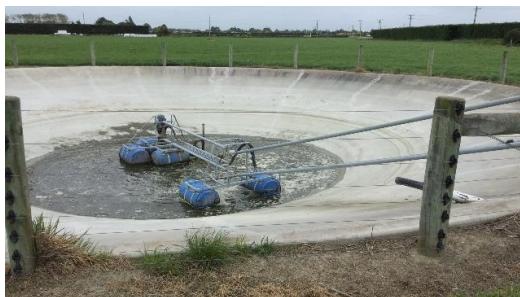
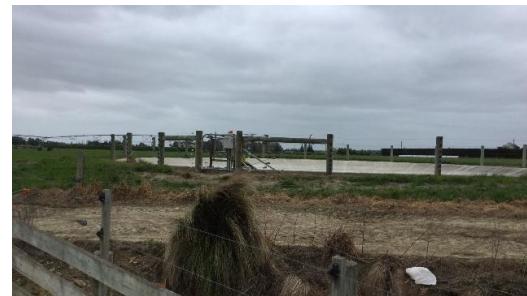
E2

The effluent storage system consists of a concrete stone trap, and sump which is pumped into a concrete lined saucer. Plucks designed and build the storage system as per design plans which are on record. The storage system is fenced off.

Recently they have installed Clear Tech which separates and cleans the effluent so that the clear water can be reused for wash down water. Current testing is showing a 70% water reduction. This has meant that they are now getting 16 days storage in their saucer.

The risk to water quality is low as there is sufficient storage and the system is fully contained and sealed.

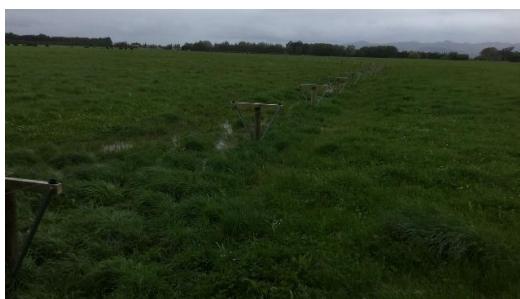
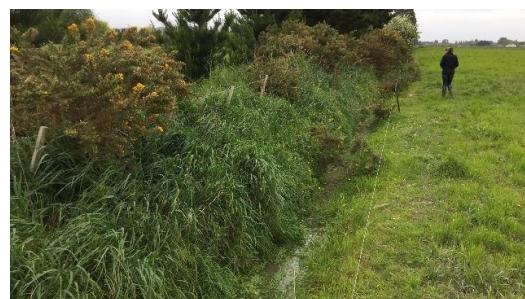
W1

The waterways on the south block are intermittently flowing drains. They are all permanently fence to prevent stock access. All waterways are fenced with a 3m average distance. There are also concrete troughs in place to act as a sediment trap.

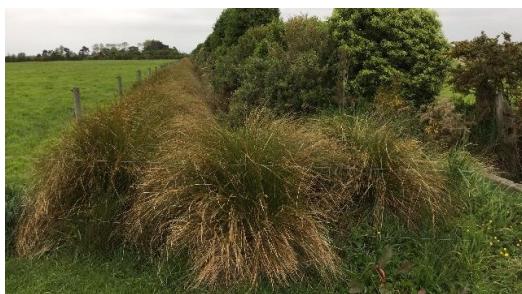
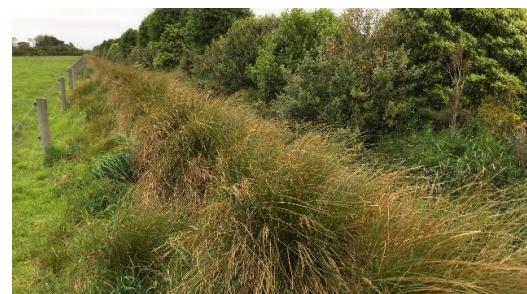
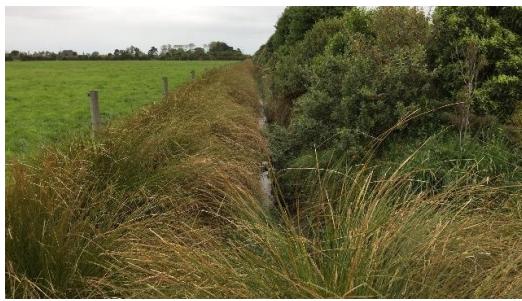
W2

There are two areas where waterways boundary the property. These have been planted to reduce the risk of sediment and nutrients entering the waterway. They are planted with natives either side. One edge is planted with Sedge and has a 3m buffer the other edge is planted with flax and pittosporums with a 5m buffer.
